**POLYMER CONCRETE MICRO-OVERLAY
FOR FUEL AND ABRASION RESISTANT SURFACING:
LABORATORY RESULTS AND FIELD DEMONSTRATIONS**

**By
Kent Newman, PhD
and
James E. Shoenberger, PhD**

**US Army Engineer Research and Development Center
Vicksburg, Mississippi, USA**

**PRESENTED FOR THE 2002 FEDERAL AVIATION ADMINISTRATION
AIRPORT TECHNOLOGY TRANSFER CONFERENCE**

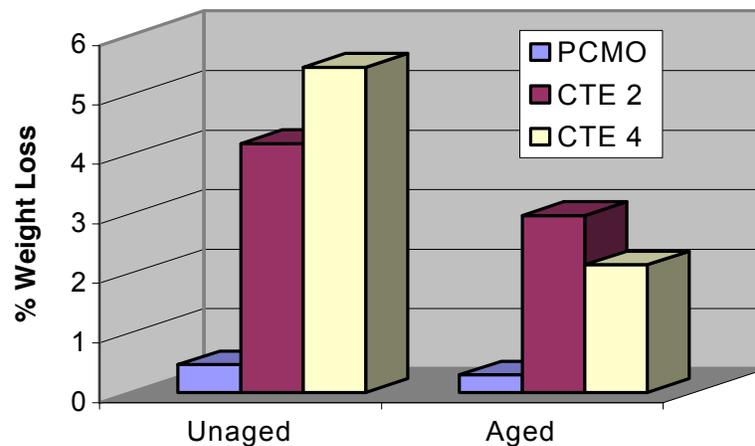
The results of the abrasion testing indicate that the unsealed PCMO material is approximately 8 to 10 times more abrasion resistant than a standard coal tar emulsion. The sealed PCMO is approximately 2 times more abrasion resistant than the CTE. The difference between the sealed and unsealed PCMO indicates that the surface sealer is abraded more rapidly than the PCMO base. Although the abrasion resistance of the CTE's is higher after aging due to embrittlement, it is well documented that these materials exhibit severe “chicken-wire” or “map” cracking with age and must be resealed every 2-5 years (Shoenberger, 1993 and Saraf et al., 1992). There is no statistical loss in abrasion resistance after aging of the PCMO material.

Figure 1. Abrasion resistance of PCMO compared to coal tar emulsion using a modified form of the wet track abrasion test.

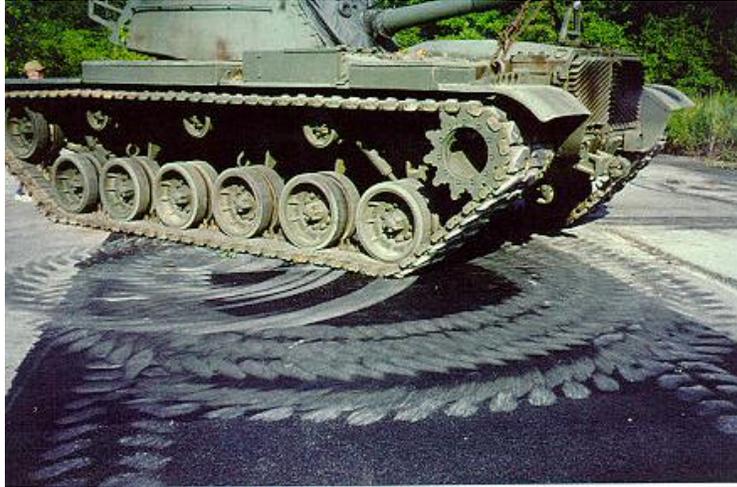
On Friday, August 28, 1998 an M-60 tank (approximately 106,000 lbs gross weight or 53 tons) was employed as a test vehicle (Figure 2). Tracked vehicles (with rubber pads) cause

Ten total pivot steers were conducted on the PCMO surfaces with no delamination from the underlying asphalt. The damage to the PCMO surface was some scuffing of the surface in areas with a surface layer of broadcast sand. The sand had sheared loose from the surface and caused scuffing under the tank treads. No delamination of the PCMO was noted. The tank testing ended prematurely with the rupture of a fuel line on the tank spilling 2-3 gallons of diesel onto the PCMO surface. After 2 days, no residue of the fuel or staining of the PCMO was apparent.

Figure 2. 106,000 lb M-60 tank conducting pivot steers on PCMO surface at US Army ERDC.

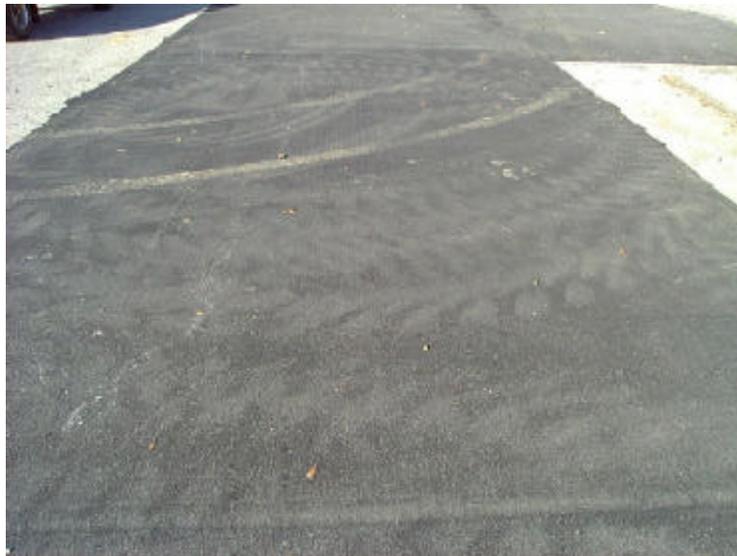
In October 2001, the PCMO section at Vicksburg displayed 2 cracks, both reflecting from cracks in the underlying asphalt. Both of the cracks were smaller in width than the underlying cracks in the asphalt. Scuff marks from the tank testing were still visible although not distinctive (Figure 3). BPNs were on the order of those from typical asphalt. The adhesion tests showed excellent adhesion to the asphalt. The asphalt pulled apart (cohesive asphalt failure) rather than the PCMO pulling away from the asphalt surface (adhesive failure). This indicates strong adhesion to the asphalt.

Figure 3. PCMO surface in October 2001. Some scuffing of the surface from the tank testing in August 1998 is apparent.

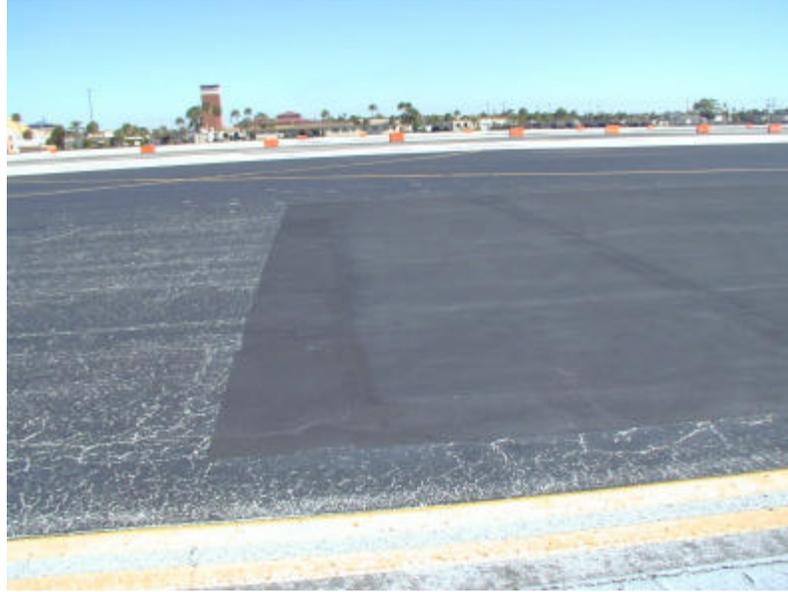
Figure 4. PCMO surface in October 2000 at MacDill AFB. The adjacent pavement is coal tar that is approximately 14 years old and is severely deteriorated.

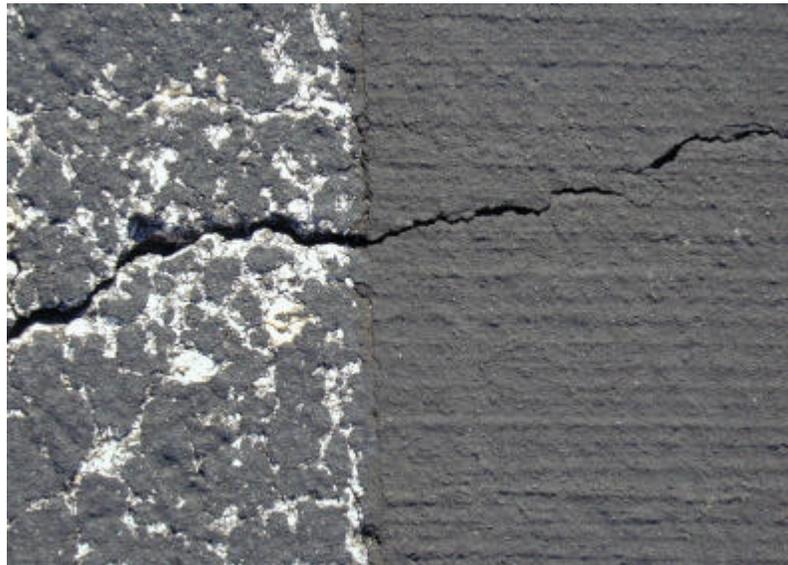
that many of the reflective cracks in the coal-tar layer did not propagate up through the PCMO layer. In several locations along the edge of the PCMO sections, cracks in the coal-tar were visible running up to the edge but did not proceed into the overlying PCMO layer. Adhesion tests pulled up the underlying coal-tar and the frictional resistance was similar to asphalt. The PCMO pavement marking line was in excellent condition when compared to the distressed conventional paint striping (Figure 6).

Figure 5. PCMO section at MacDill AFB showing reflective cracking. Note that the crack has not widened or displayed any raveling from the crack face.

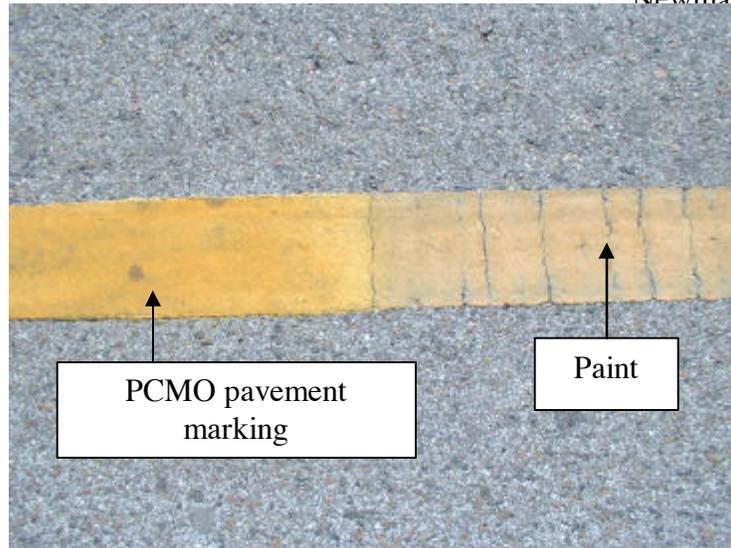
Figure 6. PCMO pavement marking line at MacDill AFB in October 2000 after 2 full years in service. Note the transverse cracking in the conventional airfield pavement marking paint. The marking paint is approximately 3 years old in this picture.

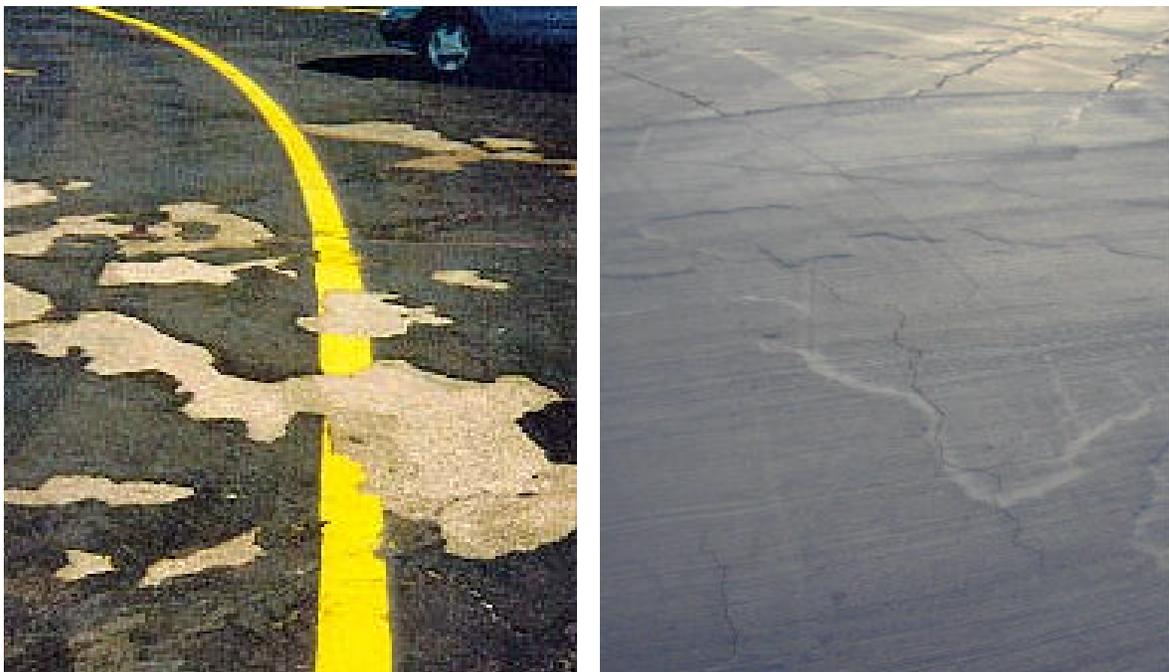
Section 2 was a small area placed over severely delaminating coal tar. The purpose was to determine if the PCMO was able to encapsulate the existing coal tar. It appears to have accomplished this by preventing further adhesion loss of the coal tar from the asphalt (Figure 7).

Figure 7. “Delaminated coal tar area before (1998) and after sealing with PCMO (2000) at Forbes Field, Topeka, KS.
